RESEARCH MEMORANDUM

PRELIMINARY INVESTIGATION OF SEVERAL ROOT DESIGNS FOR

CERMET TURBINE BLADES IN TURBOJET ENGINE

II - ROOT DESIGN ALTERATIONS

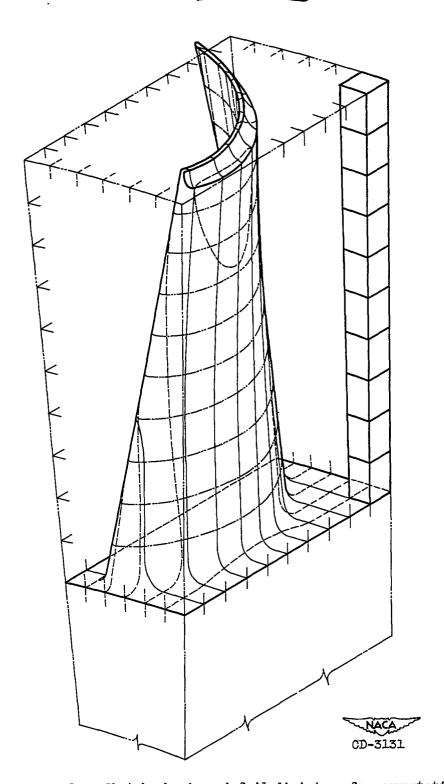
Figure 9. - Sketch showing airfoil divisions for computation.

Calculation procedure. - The airfoil span or length was divided into 10 sections. The profiles of the sections were drawn to five times the size. The base profile was subdivided into small squares 1/2 inch on a side (0.1 inch on a side at actual blade size.) All other profiles were correspondingly subdivided into rectangles 1/2 inch in the direction of the turbine wheel axis and slightly greater than 1/2 inch in the tangential direction. The correction in tangential distance is due to the increase in chord length of a radial segment as the radial distance increases, as sketched diagrammatically in figure 9. The volumes of the small airfoil pieces between corresponding rectangles of each station were calculated and totalled. The centers of gravities and the radial distances of the resulting long thin radial columns were computed to permit calculation of the centrifugal force acting on each square of the base airfoil profile due to its respective column.
